TS-PIC-9902269S
March 1999

AERIAL PHOTOGRAPHIC ANALYSIS
LCP CHEMICALS, INC., SITE

Linden, New Jersey

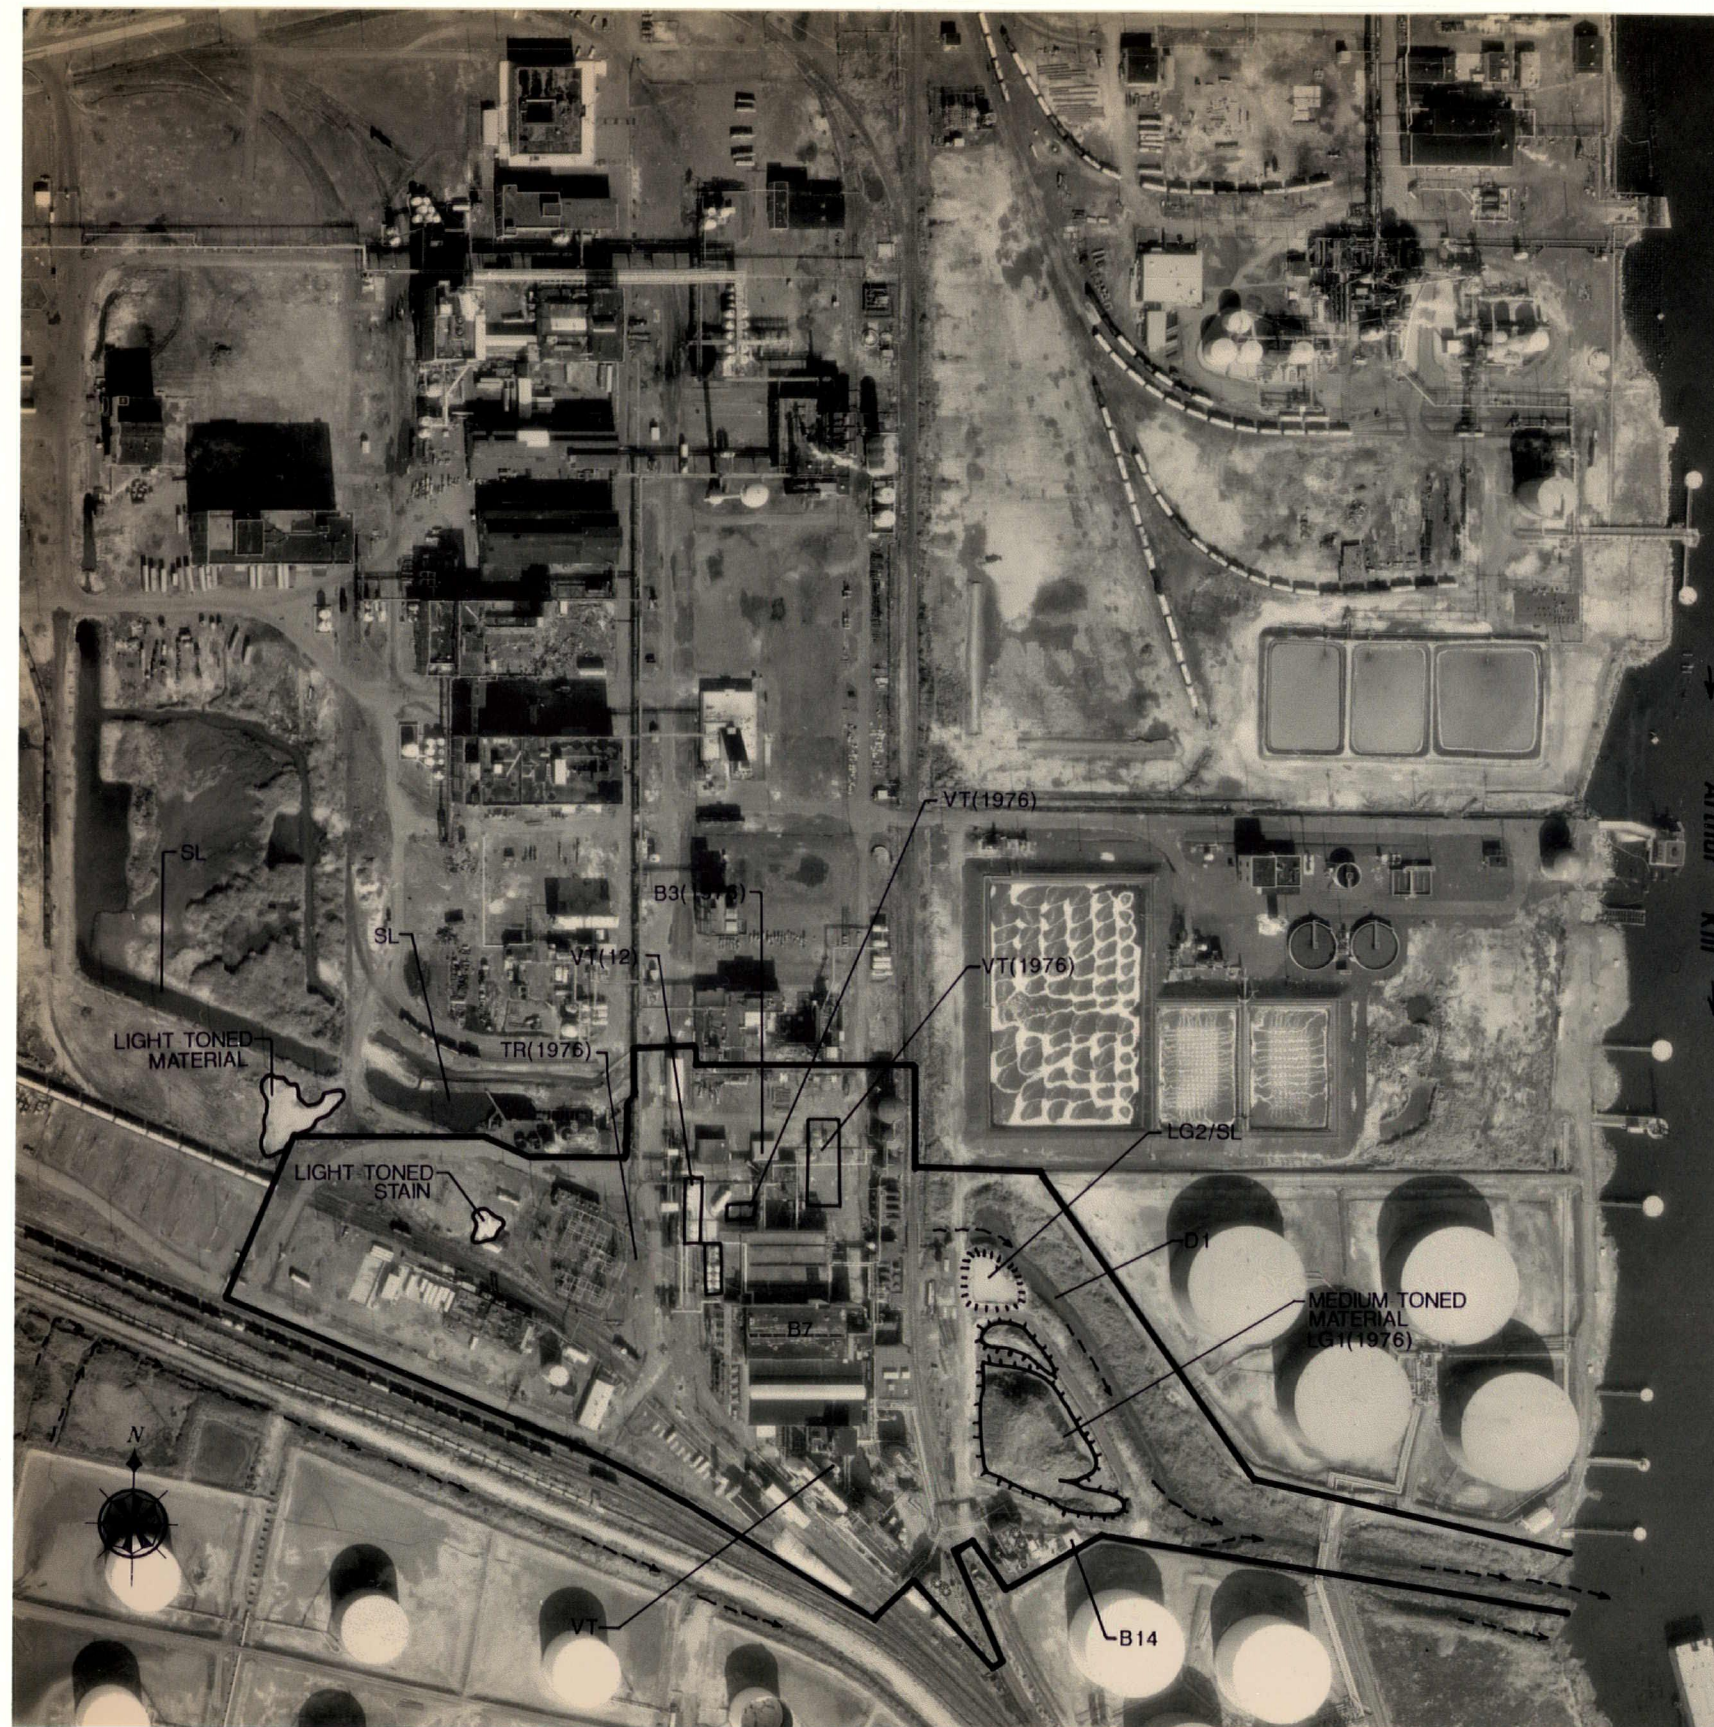
Figure 10. LCP Chemicals, Inc., site, November 7, 1982. Approximate scale 1:4,000.

NOVEMBER 7, 1982 (FIGURE 10)

The LCP Chemicals, Inc., site continues to be operational. The large excavated trench observed in 1976 has been filled and leveled. Nine vertical storage or processing tanks have been removed from the east side of the chemical plant. Twelve new vertical tanks are observed on the west side of the plant near the railroad tank car loading racks area. One vertical tank has been constructed south of building B7.

A small lagoon containing standing liquid (LG2/SL) has been constructed on the north side of the former large lagoon LG1. The former large lagoon LG1 has been filled with a dry, medium-toned material that forms a large mound.

A light-toned possible stain is seen in the western portion of the site. A larger area of light-toned material is seen located outside and adjoining the northwestern corner of the site.

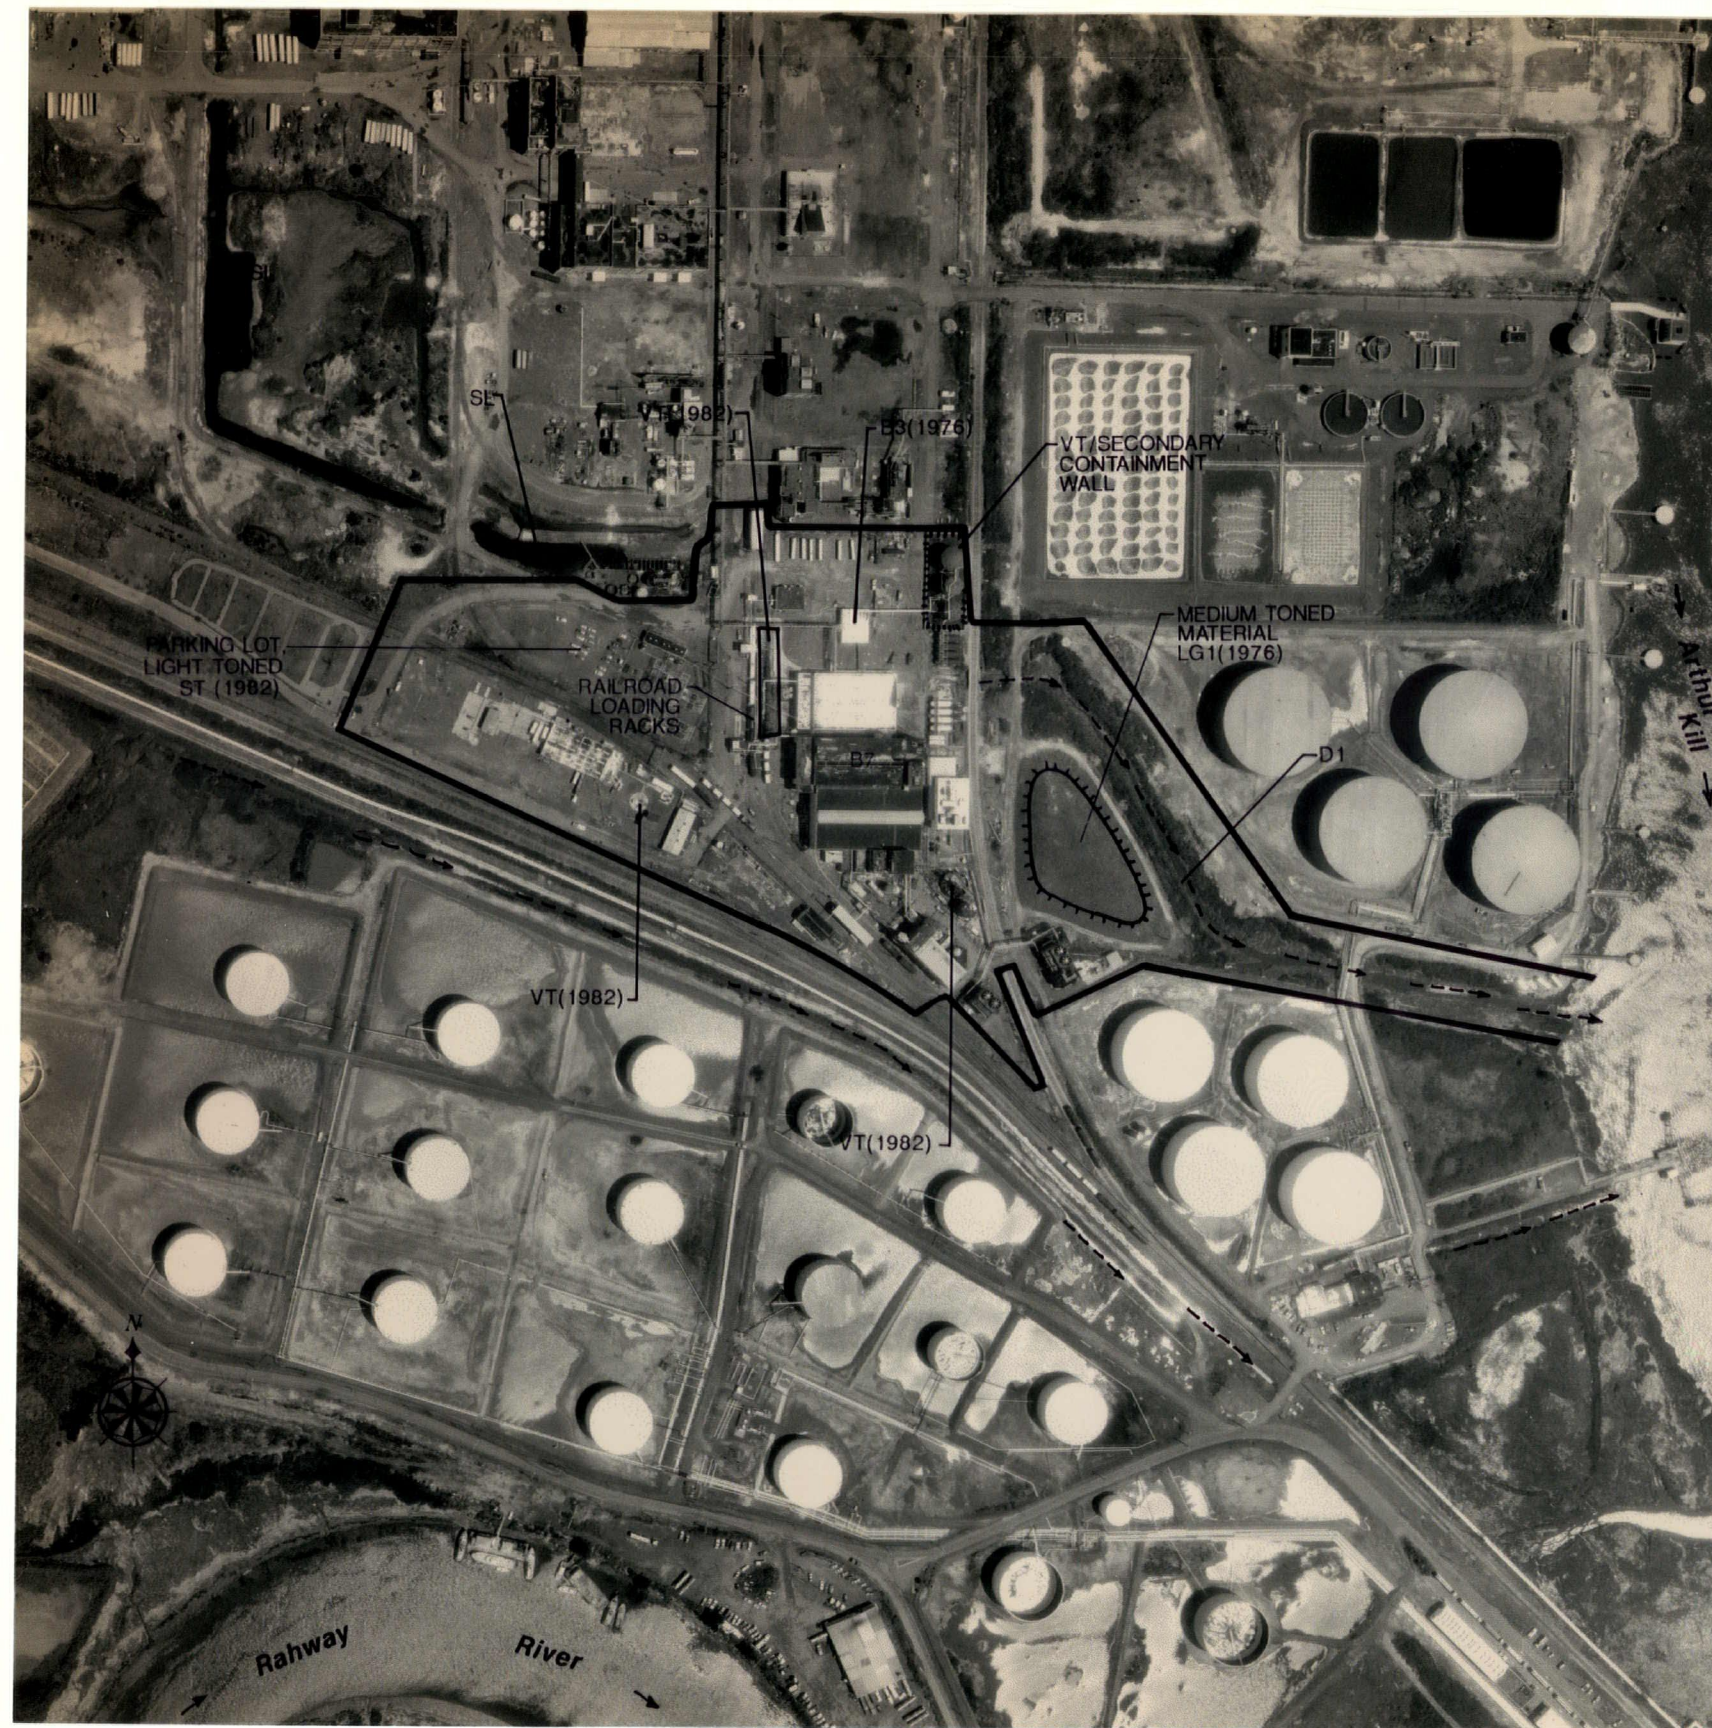
Figure 11. LCP Chemicals, Inc., site, June 22, 1990. Approximate scale 1:4,300.

JUNE 22, 1990 (FIGURE 11)

The LCP Chemicals, Inc., site appears to remain operational. Railroad tank cars (not annotated) are visible at the loading racks. Since 1982 twelve vertical tanks have been removed near the railroad tank car loading racks area.

A secondary containment wall has been constructed around a group of vertical tanks in the northeast corner of the site. No ground stains are discernible.

The small lagoon (LG2) observed in 1982 has been removed and the location has been graded and leveled. The former large lagoon LG1 is absent and a medium-toned large mound of material occupies this location. This large mound has been graded and contoured.

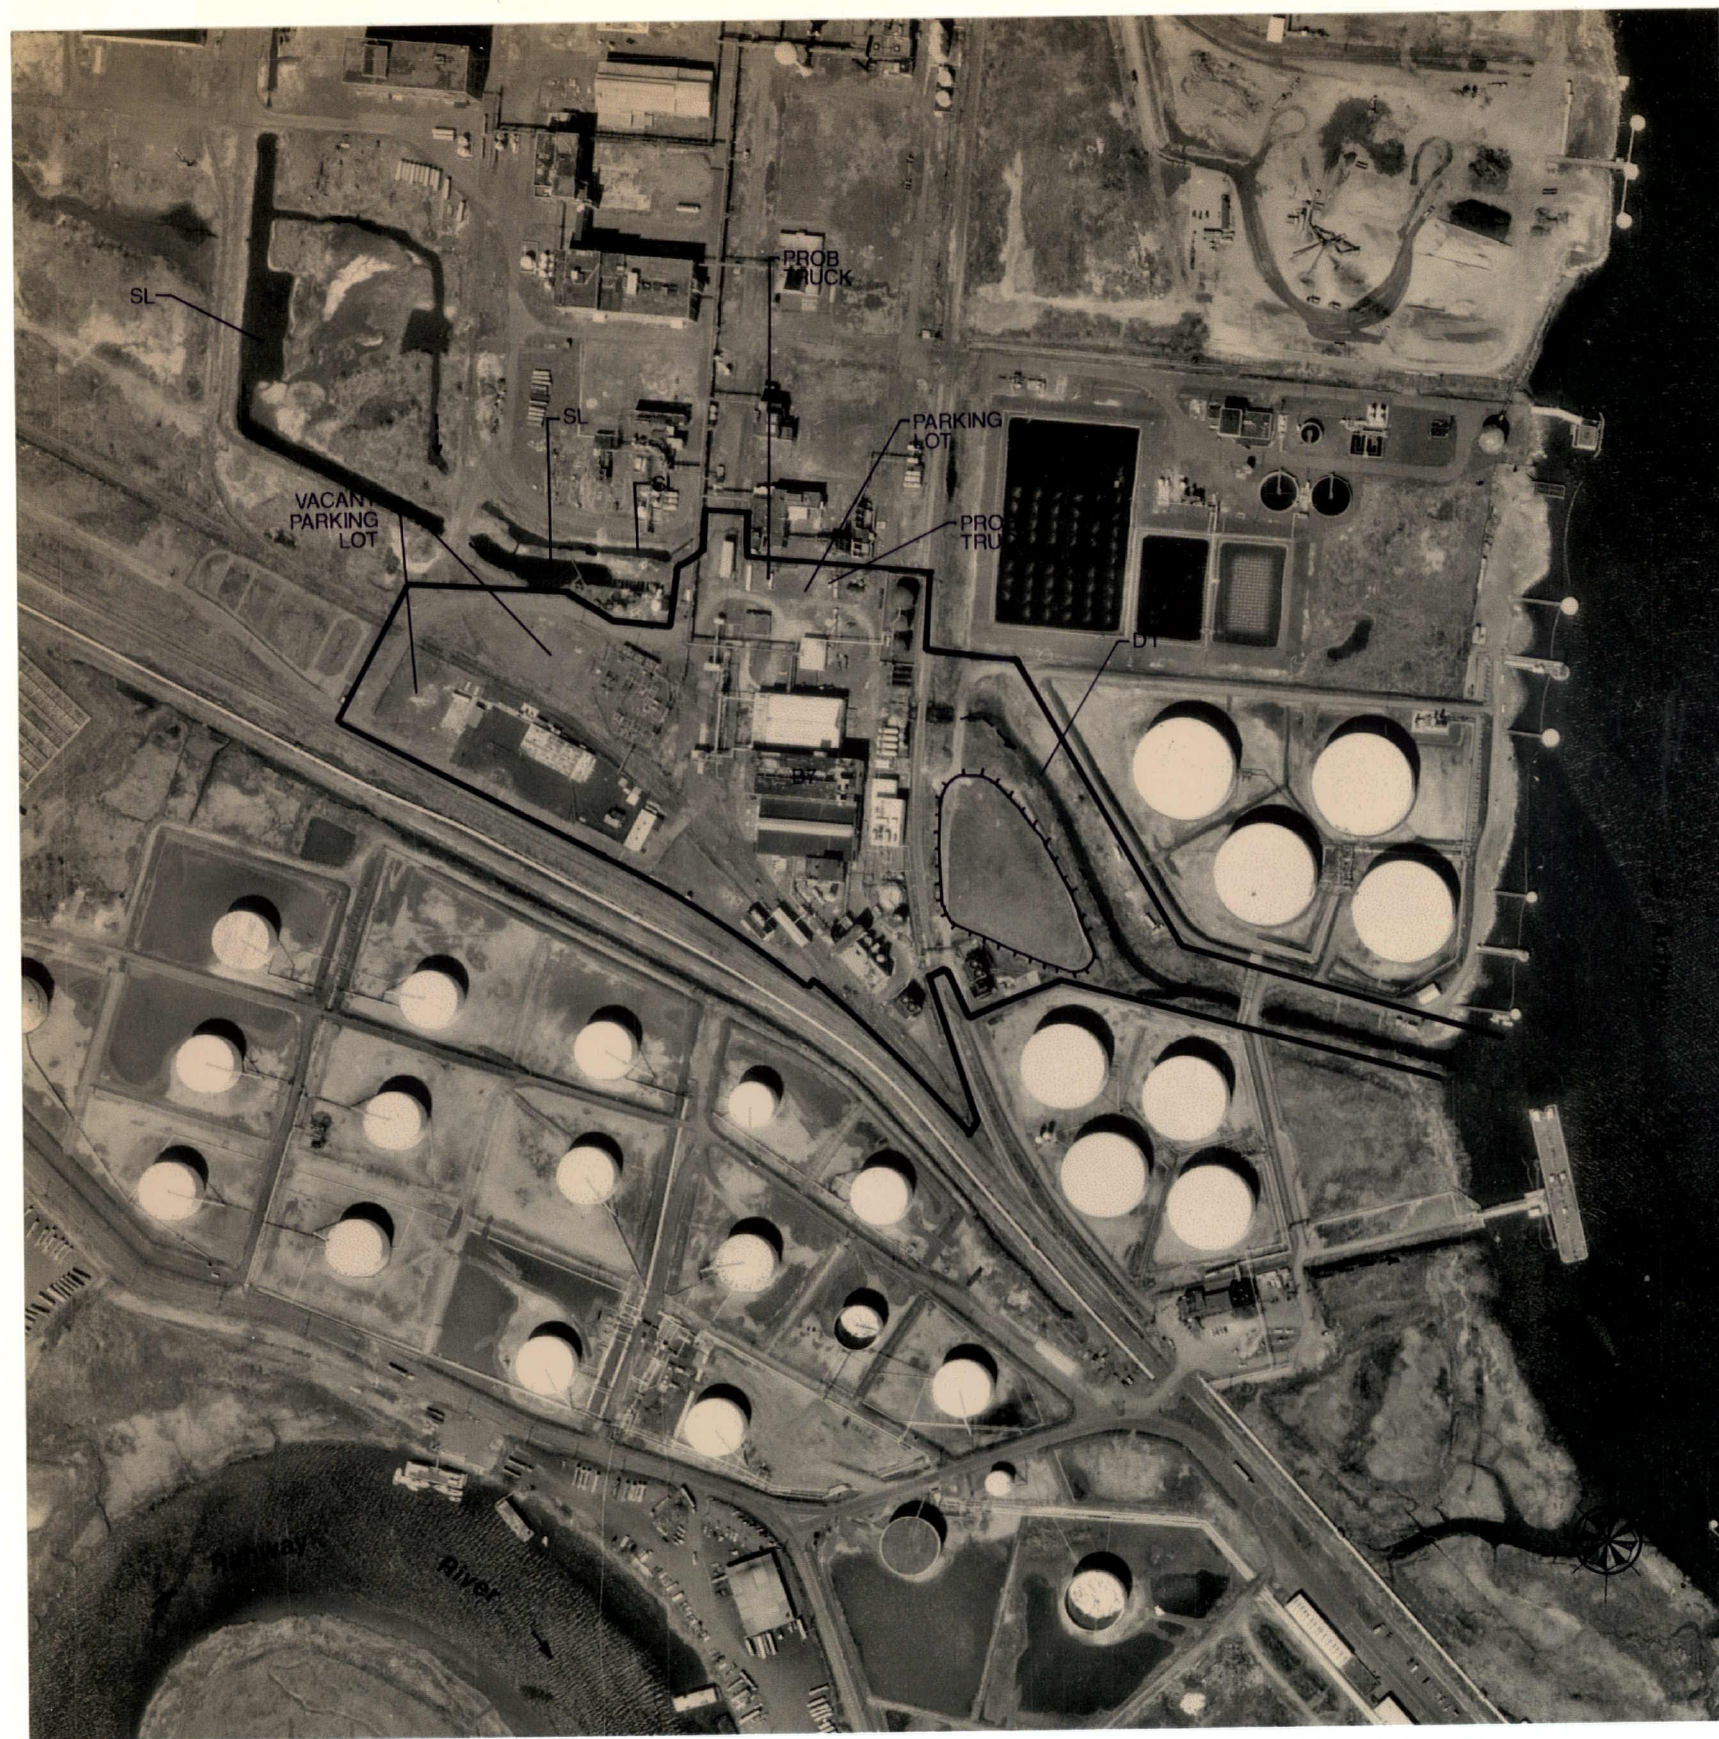
Figure 12. LCP Chemicals, Inc., site, April 3, 1995. Approximate scale 1:4,600.

APRIL 3, 1995 (FIGURE 12)

The LCP Chemicals, Inc., site appears non-operational. There are no railroad tank cars or tank trucks visible at the loading racks. There are no discernible vehicles and only two probable trucks noted within the plant and associated parking lots.

The drainage ditch D1 continues to flow into the Arthur Kill and no discernible plume is observed from this ditch.
